Installation instructions

For set # 11.3110
06-UP Mazda MX-5 Miata
Rear Control Arm Bushing Set

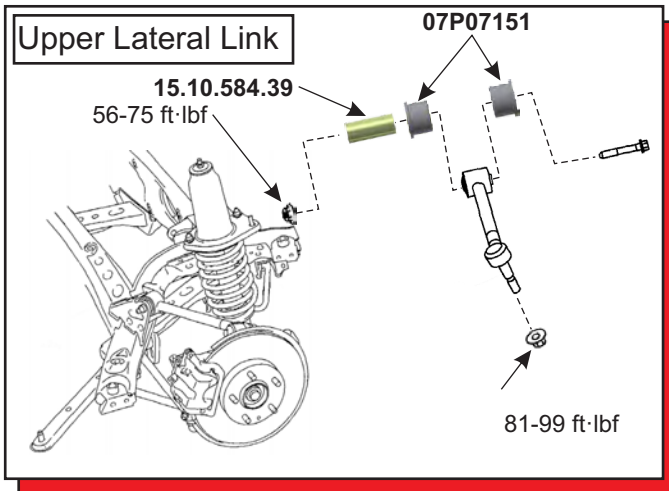
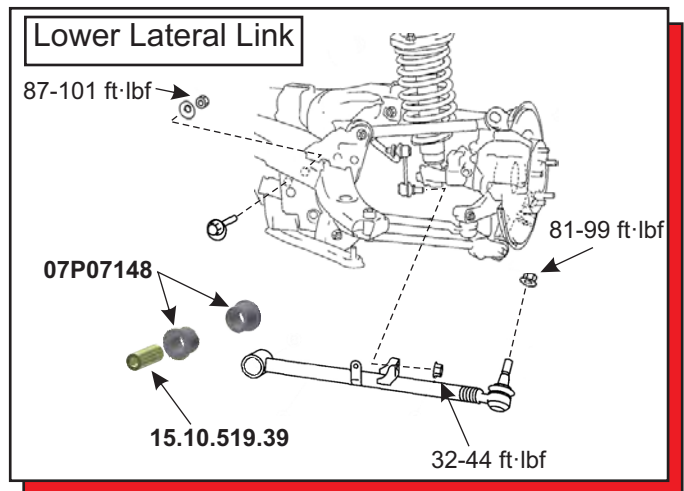
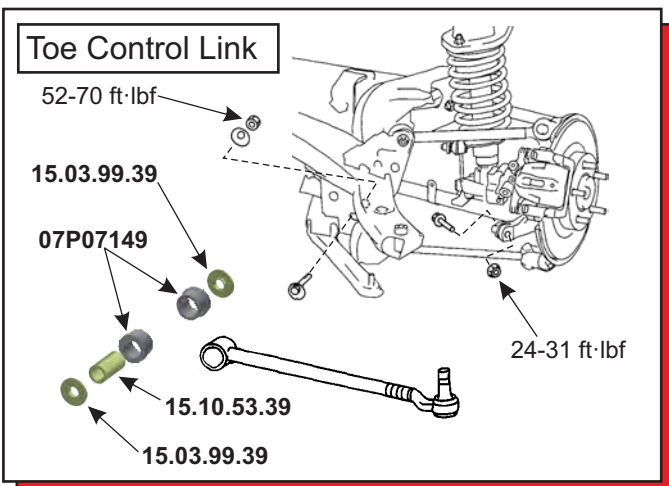
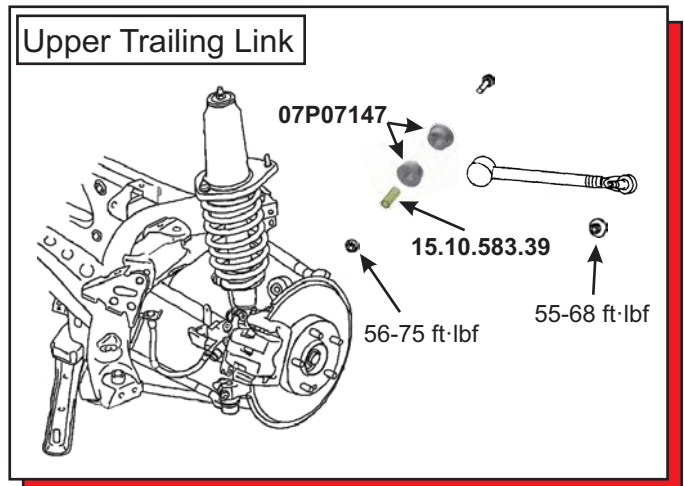
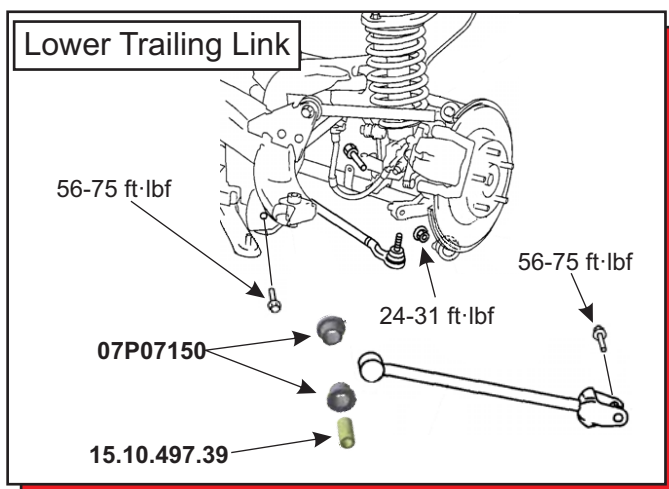
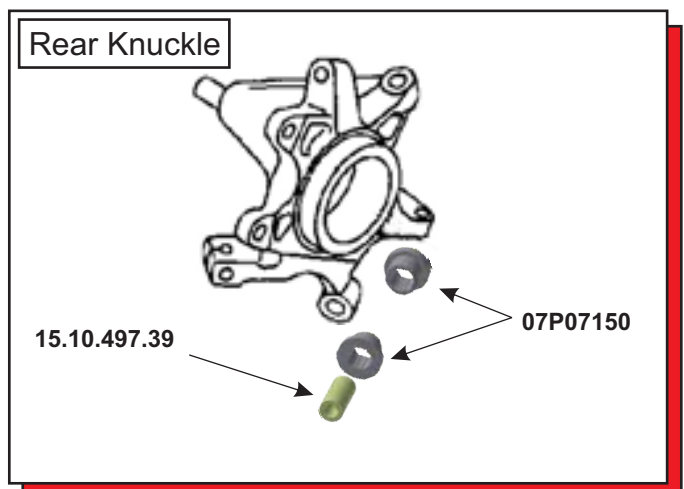
REMOVAL: Properly lift and support the vehicle with jack stands. Remove both rear wheels. Place matchmark on the front and rear adjusting cams before you start. You will need to use these matchmark to reinstall the toe control links back in the same position after the new polyurethane bushings are installed. Only remove one link at a time, this will keep the rear knuckle supported and easy to reinstall the links. To remove the rubber bushing and sleeve out of the eye. Use a propane or MAPP gas torch and, with a fairly hot flame, slowly heat the exposed circumference of the eye. USE EXTREME CAUTION WHEN HEATING AND REMOVING THE OLD RUBBER AND SLEEVE AS THEY ARE UNDER PRE-LOAD AND CAN "SHOOT" OUT OF THE EYE. Make sure to keep the flame moving and not to hold it in one spot for too long. It is usually best to work the flame around the outside of the bushing in a circle. When sizzling/smoke is seen, the bond between the bushing and sleeve is broken and the bushing can be carefully pushed out with pliers or a screwdriver. Once bushing/sleeve is out, clean out all scraps of rubber and use emery paper to remove the sharp edges from ID of eye as preparation for new polyurethane bushing. To remove the old rubber bushing from the lower position on the knuckle use a piece of all-thread, tubing, flat washers and nuts. The tubing needs to be big enough for the old bushing to fall into. Tighten the nuts until the old bushing falls out.

INSTALLATION: Grease all sides of the bushing that contact metal. Grease the I.D. of the eyes and the O.D. of the new sleeves. Use an arbor press to install the new polyurethane bushings. Reinstall the links into the vehicle and torque all nuts and bolts to factory specs. It is recommended that you have the alignment checked on your vehicle at a qualified alignment shop after replacing the bushings.
