Installation instructions

05-07 Scion TC

Set # 8.1104

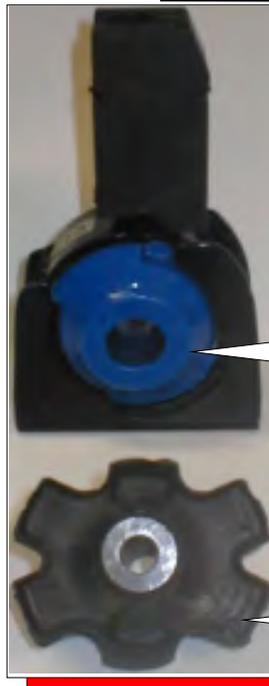
Bushing 1259
Sleeve 15.10.597.39 (NOT SHOWN)

O.E.M. Rubber bushing

- 1242 - Rear torque mount with the shorter sleeve
- 1249 - Transmission mount front position
- 1250 - Transmission mount rear position
- 1259 - Front torque mount position
- 15.10.472.39 (.875" x .500" x 2.355")
- 15.10.594.39 (.875" x .406" x 2.810")
- 15.10.597.39 (.875" x .406" x 2.550")

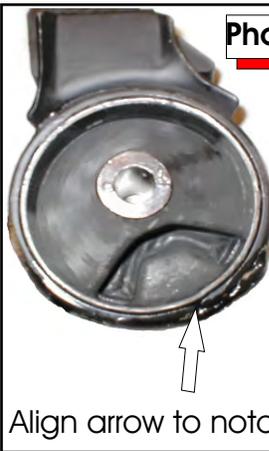
Photo 1

Align arrow to notch

NOTE: Align the arrow on bushing 1242 with the notch on the motor mount. (photo 1)
