INSTRUCTION SHEET FOR SET #8.3120 TOYOTA MATRIX/COROLLA

BILL OF MATERIAL

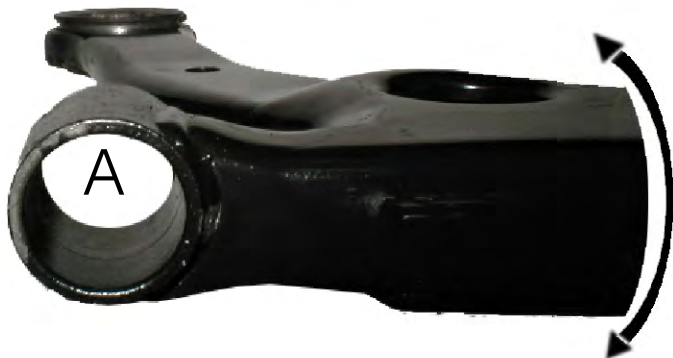
Diagram V

- The center bushing #3304 must be installed with the engraved arrow pointing towards front of car, or the horizontal position **Point A**. If you looked thru the horizontal eye, **Point A**, the cross-section of the vertical bushing assembly would look like **Diagram V**.

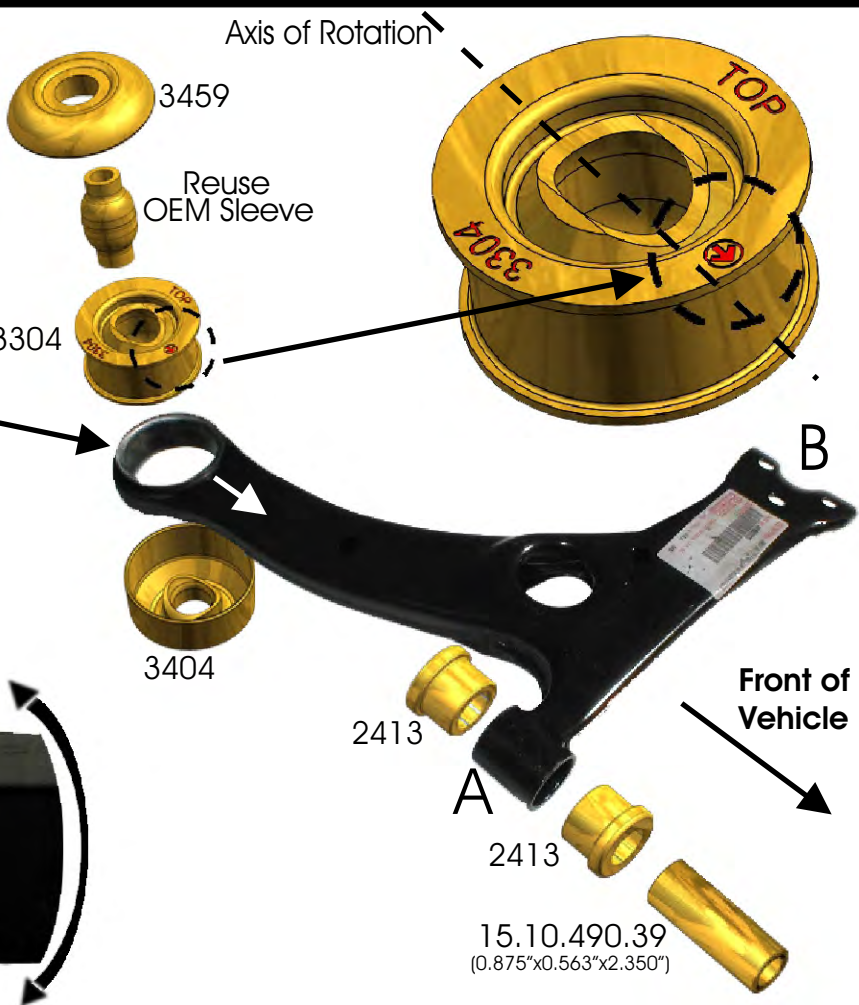
Remove the OEM rubber bushings, using heat to break down their glue bond. **DO NOT remove the metal shell** pressed in at the vertical position. Also don't throw away the inner metal sleeve, it is reused. Now de-burr any rough edges and clean out any leftover debris at the vertical and horizontal positions of the arm.

Do not remove metal shell
