INSTRUCTION SHEET FOR SET #8.3120 TOYOTA MATRIX/COROLLA

BILL OF MATERIAL

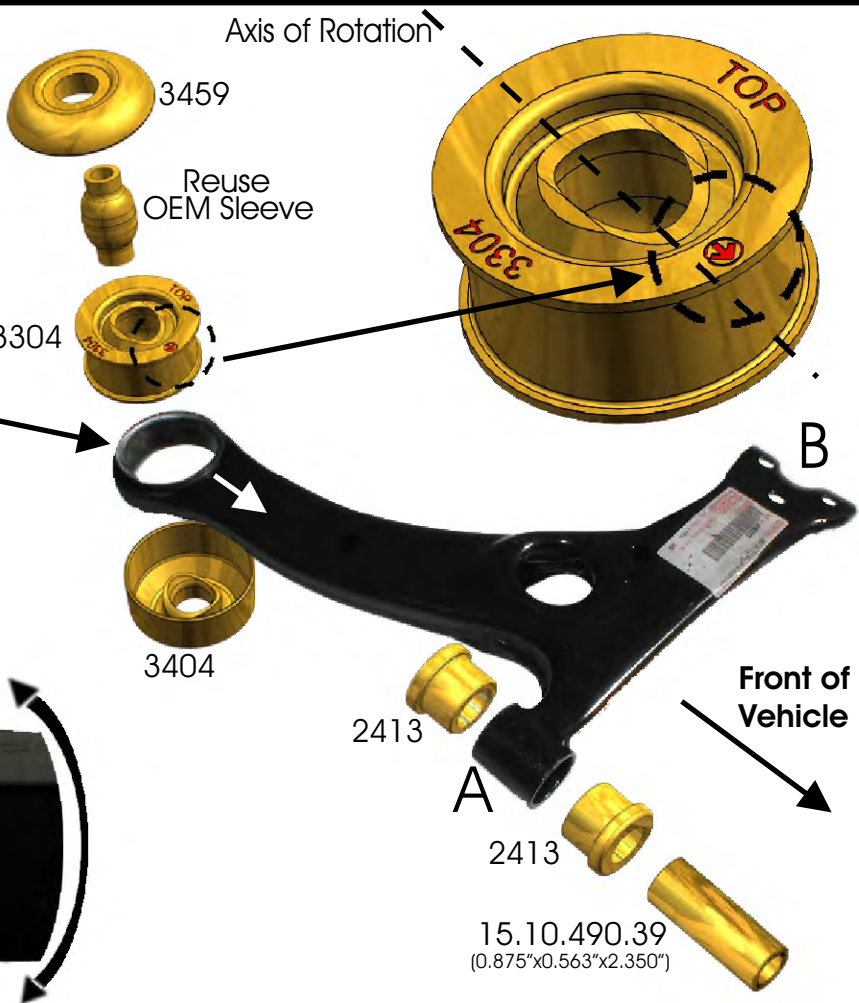
Remove the OEM rubber bushings, using heat to break down their glue bond. **DO NOT remove the metal shell** pressed in at the vertical position. Also don't throw away the inner metal sleeve, it is reused. Now de-burr any rough edges and clean out any leftover debris at the vertical and horizontal positions of the arm.

Do not remove metal shell
