Instruction Sheet #3.3187

Front Control Arm Set

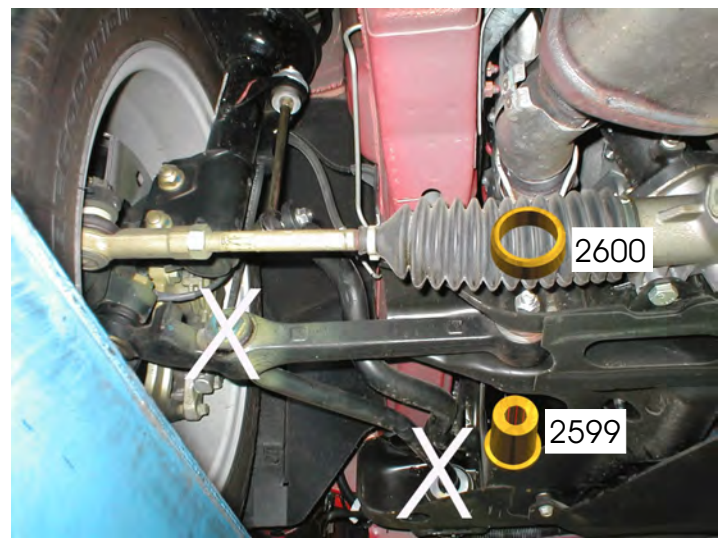
Once the OEM shell and bushing have been removed, clean out the eye of the arm. Also remove any sharp burrs in the metal. Now grease the ID of the arm and the OD/ID of bushing #2599. Install #2599 in from the front (see pic). Install the #2600 thrust washer bushing over #2599. Now install supplied sleeve. Reinstall arm and now tighten all bolts back to factory specifications.

Due to design constraints and safety concerns, no bushings were made for the strut arm positions. These positions are seen by an X. (see pic)

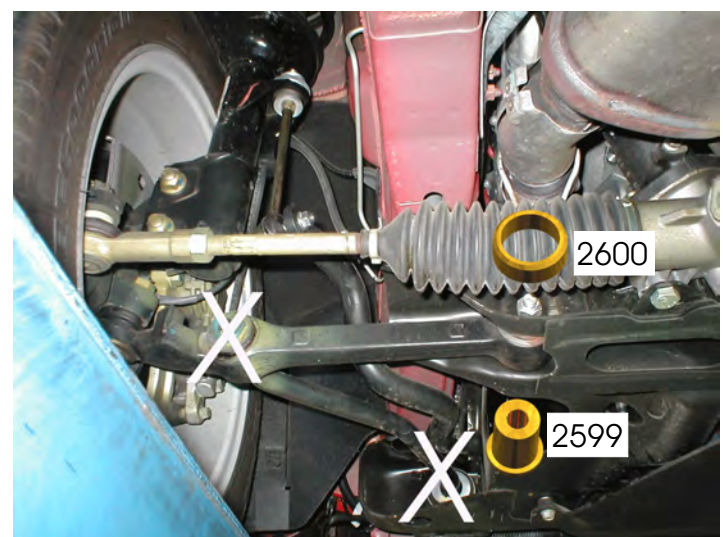
Once the OEM shell and bushing have been removed, clean out the eye of the arm. Also remove any sharp burrs in the metal. Now grease the ID of the arm and the OD/ID of bushing #2599. Install #2599 in from the front (see pic). Install the #2600 thrust washer bushing over #2599. Now install supplied sleeve. Reinstall arm and now tighten all bolts back to factory specifications.

Due to design constraints and safety concerns, no bushings were made for the strut arm positions. These positions are seen by an X. (see pic)
