# Installation Instructions for Set # 3.3191 63-82 Corvette

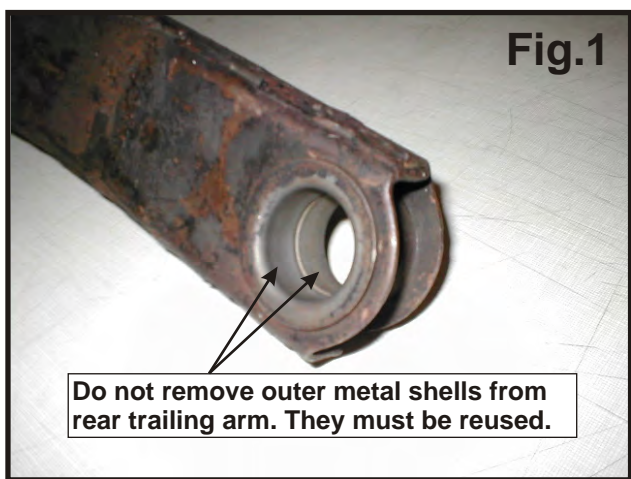
**Note: Do not remove outer metal shell that is pressed into the trailing arm. See Fig. 1 This outer metal shell must be reused!**

(If your original outer metal shell is unuseable, get new replacements from GM, P/N 3743857).

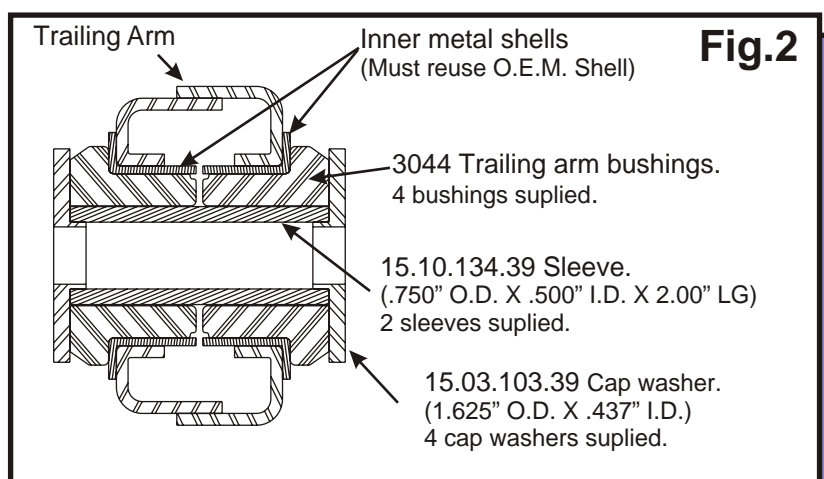
4. Refer to (Fig. 2) for assembly of your new polyurethane bushings.

3. Clean inside of inner metal shell of any old rubber or rust. When installing polyurethane bushings, apply grease as instructed: Apply light coat of grease to I.D. of the metal shell. Apply light coat of grease to the I.D. and O.D. of bushings (all surfaces that contact metal). Apply light coat of grease to the O.D. of sleeve. Apply light coat of grease to the faces of the bushings before the cap washers are installed.

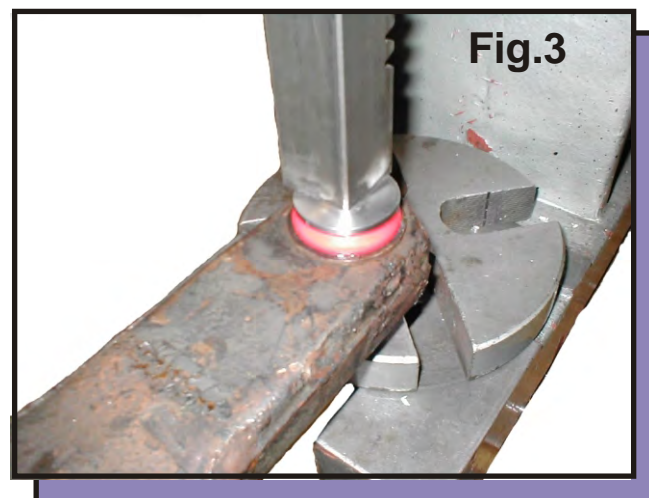
5. After applying grease to all necessary parts, use a press or vice (Fig. 3) to install the cap washers into the inner sleeve. Be sure to have the cap washers square with the new inner sleeve when pressing together (Fig. 4).
