INSTRUCTION SHEET FOR SET #5.3138

ENERGY SUSPENSION®

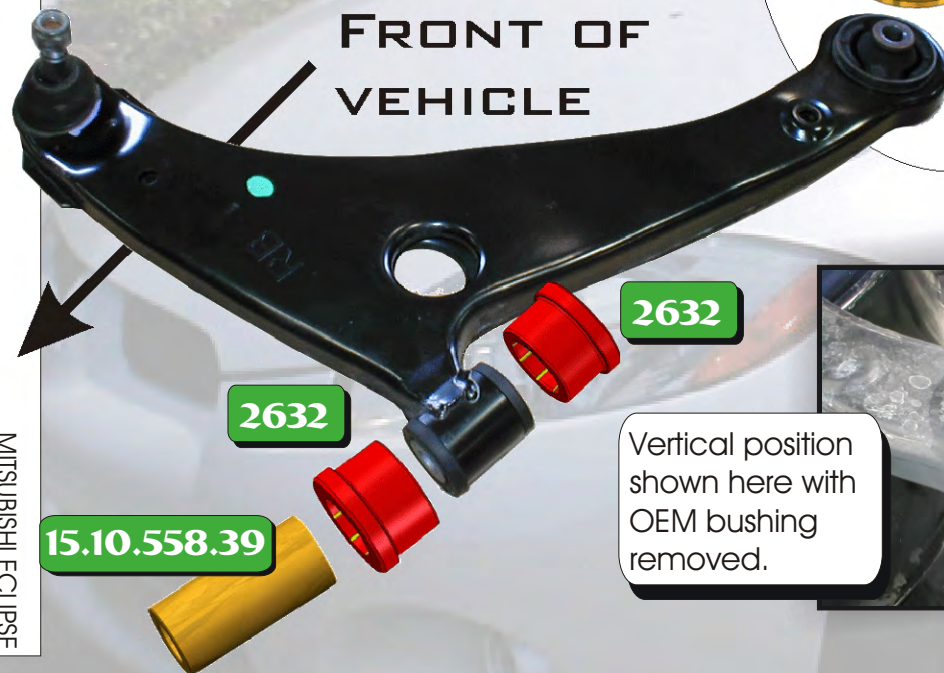
FRONT OF
VEHICLE

Press Energy bushing in with pointed flange first. (Opposite engraved #)

15.10.430.39

3465

2632

15.10.558.39

STEP 1. For the vertical position, grease the I.D.'s of the arm and the O.D. I.D.'s of the bushings. The flanges on the #3465 vertical bushing are different, press the bushing in on the side that has the "pointed" face. Lightly grease the sleeve #15.10.430.39, now install.

STEP 2. For the horizontal position, grease the I.D. of the arm and the O.D. of the bushing #2632. Install the bushings one on each side. Now grease the I.D. of the bushings and O.D. of the #15.10.558.39 sleeve, install the sleeve. Reinstall the arm and tighten the bolts according to factory specifications.
