INSTRUCTION SHEET FOR SET #7.3115

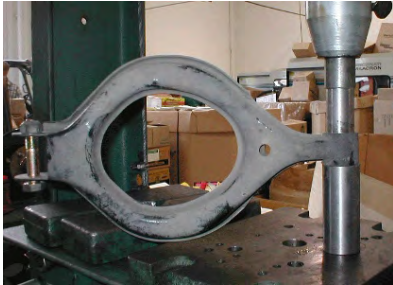
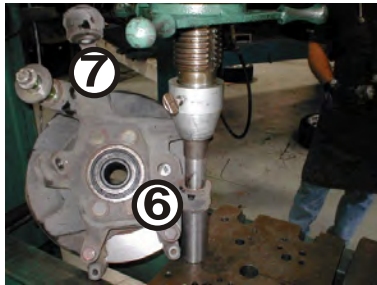
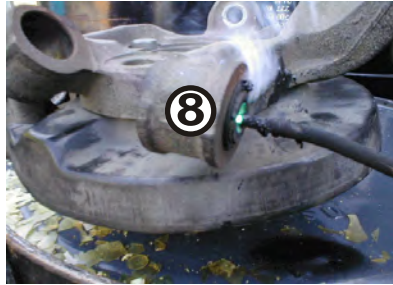
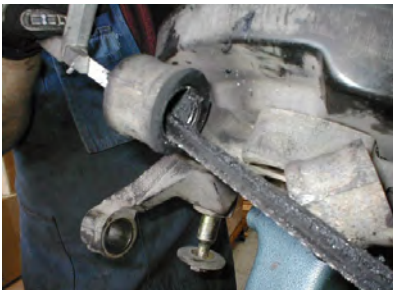
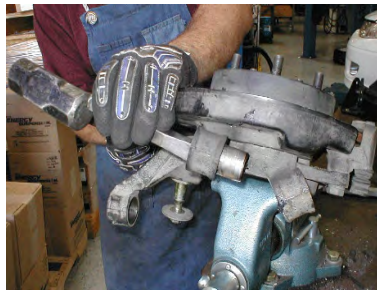
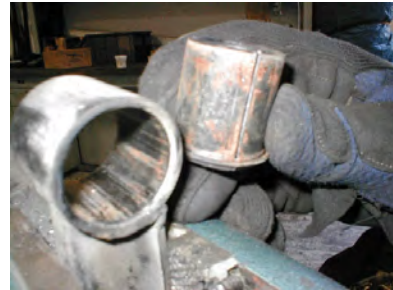
Bushing Removal: The following requires time and patience! For the lower control arm positions and the one position on the spindle (8), use heat to remove inner metal sleeve. Then, **CAREFULLY**, use a hacksaw and cut through the outer metal shell **ONLY**, this will remove the preload on the shell. Now, using a punch and hammer, you can remove the shell.

Bushing Installation: Make sure there are no rough edges, apply grease to bushings, sleeves, and ID's of arms and spindle. Press in bushings first, then press in sleeves. See parts list for locations. Installation is reverse of removal. Tighten all bolts to factory specifications.

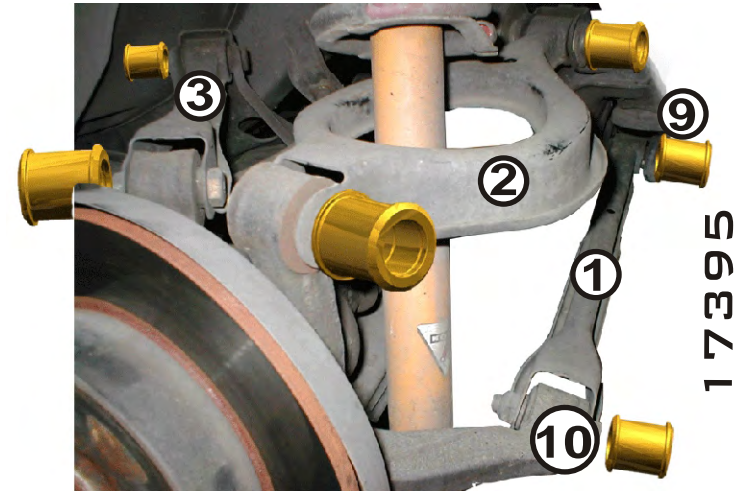
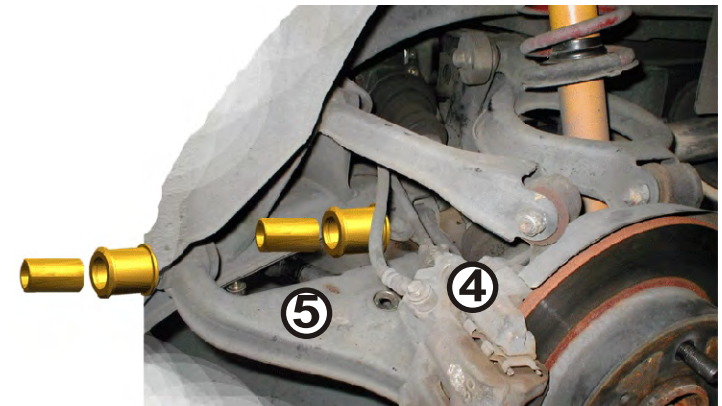
On rear hub, remove 1-7/16" nut. Remove lower ball joint nut and break loose ball joint only. Remove 14mm bolts and remove caliper.(4)
Remove 17 & 19mm rear toe link (1) bolts and remove link. **BE SURE TO SCRIBE LINES** on adjusting bolt for *estimated* realignment upon re-assembly.
Remove 17mm nut from lower shock position, slide shock off shaft. Leave shock attached at top.
Remove 19mm bolts, slide upper rear arm (2) down shock and remove.
Remove 19mm bolts and remove upper front arm (3) Remove spindle assembly.
Remove 19mm bolts from rear lower control arm (5). Remove arm.
Using a press, remove bushings from upper front arm (3), upper rear arm (2), rear toe link (1), and two positions (6,7) on spindle. **(HICAS models will not use bushings at positions (9) and (10).**

PARTS LIST:

Lower Control Arm (5)

- 4 - 8310 Control arm bushings
- 4 - 15.10.155.39 Sleeves (0.750"x0.480"x1.760")

Other arms (1,2,3)

- 12 - 8309 Upper & toe link arm bushings
- 12 - 15.10.518.39 Sleeves (0.875"x0.500"x1.565")
